HOLE-TYPE NOZZLES
WITH RESTRICTED
SPRAY ORIFICES

Workshop: EP
02.1992
0311 En

Robert Bosch GmbH
Division KH
After-Sales-Service Department for
Training and Technology (KH/VSK)

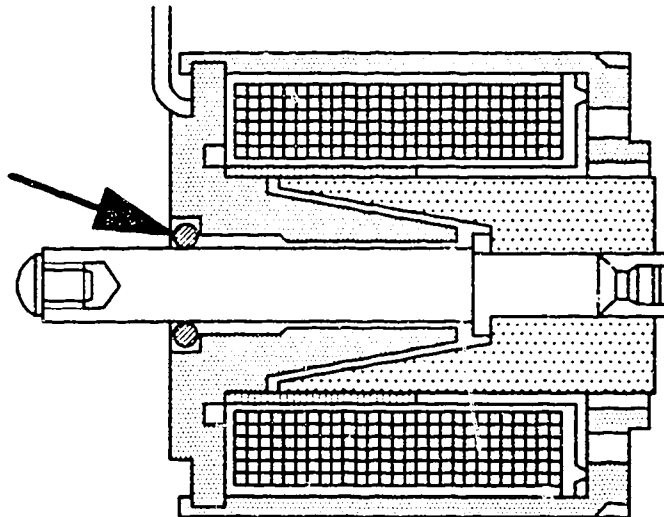
KMK02236

In the area of the bearing bore for the electromagnet-armature thrust pin, new adjusting magnets feature an O-ring in a groove to stop the electromagnet armature dropping out (picture - arrow).

This O-ring must be removed before installing a new adjusting magnet. The required magnet freedom of movement is not guaranteed with the O-ring in position.

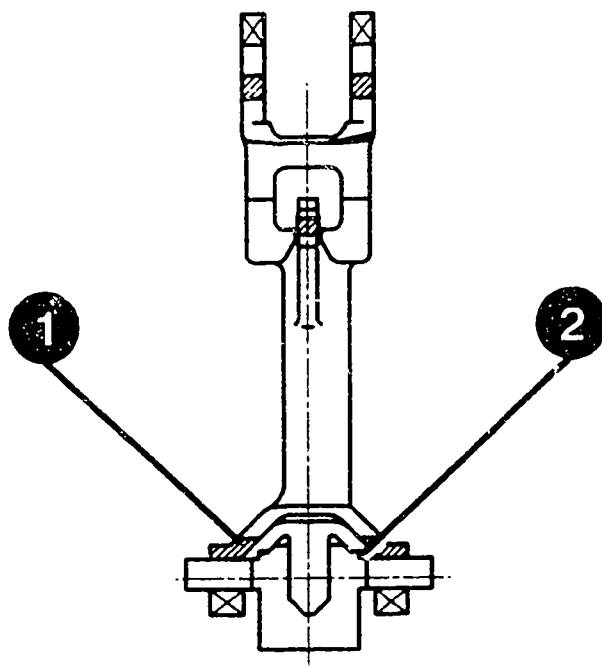
KMK02601

If, on replacing a fulcrum lever, it is established that this makes contact as shown with the sliding block, DO NOT ALTER THE FULCRUM LEVER IN ORDER TO CREATE A SPACE, but rather replace the sliding block with part no. 2 422 130 038.

When checking whether contact is made, it must be ensured that the parts are centered as illustrated.

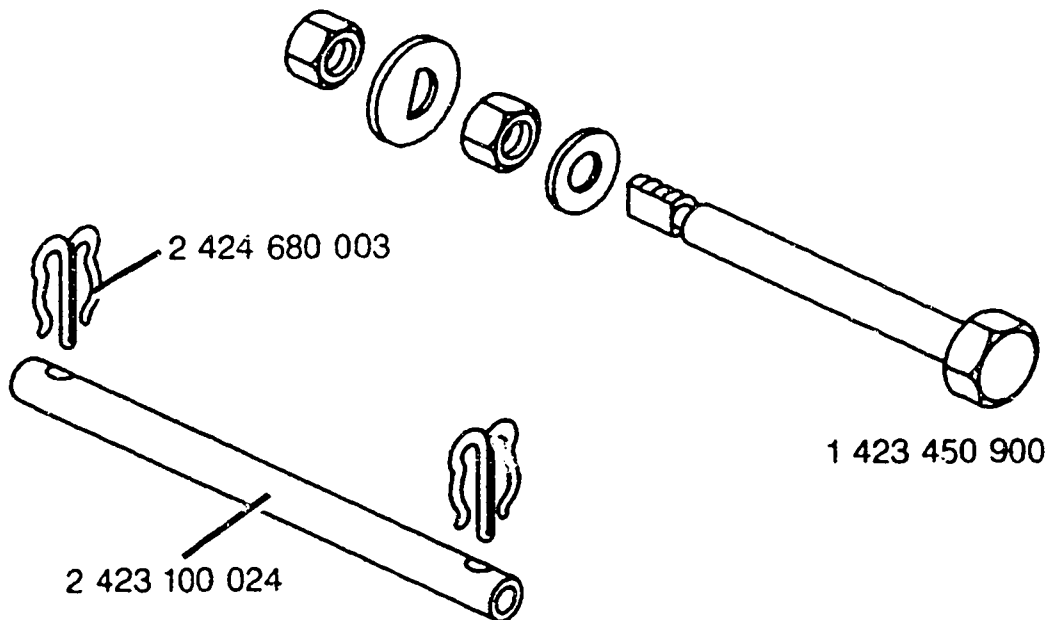
KMK02602

Recent product releases have included flywight assemblies that employ a new cross-bolt design (see illustration).

If the governor you are serving is
equipped with the new cross-bold design
DO NOT USE PARTS SET 1 423 450 900 AS
A REPLACEMENT.

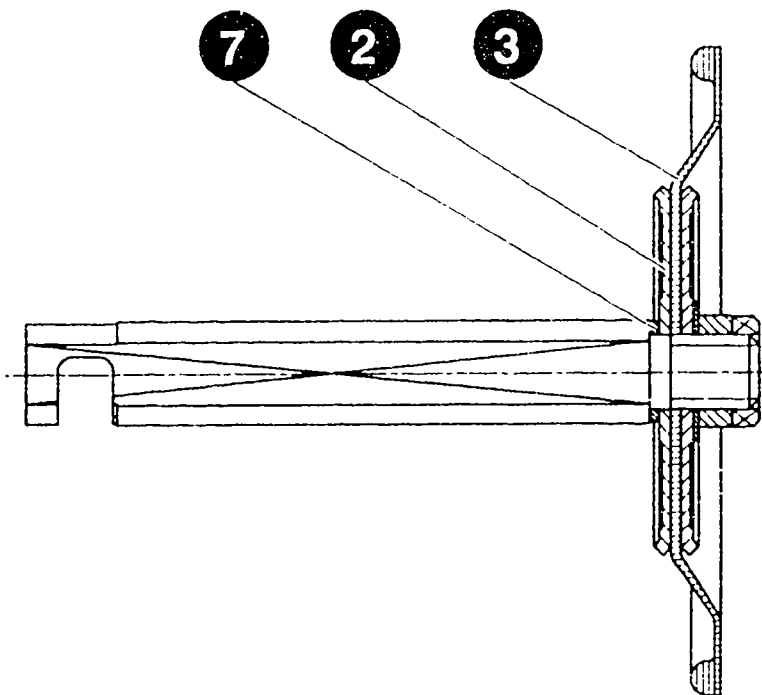
KMK02845

If the complaint "Leaking LDA
diaphragm" is received about the
above-mentioned IP assembly, then the
LDA must be converted.

Plate washer (item 2): 2 420 551 007

Diaphragm (item 3): 2 420 503 019

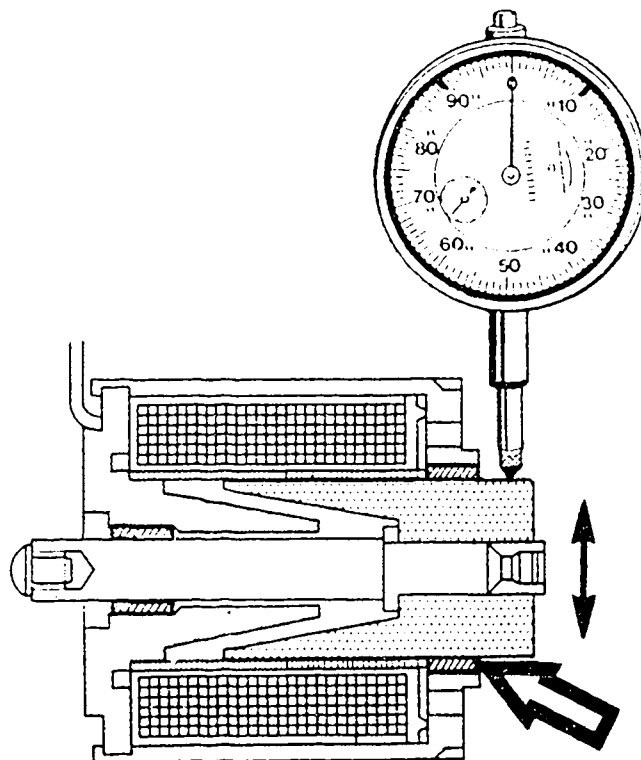
KMK 03078

The problem is usually caused by a stiff electromagnet armature in the adjusting magnet of the RE positioner due to one-sided wear of the large electromagnet-armature bushing (picture, arrow).

Such wear cannot be detected during normal testing of the IP assembly on an IP test bench. For this reason, should such complaints be received, the adjusting magnet is to be removed and the bearing wear measured.

- Completely remove positioner cover.
- Unsolder electrical connections of control-rod-travel sensor and adjusting magnet at connection plate (pay attention to soldering specifications).
- Remove control-rod-travel sensor and adjusting magnet.
- Check large bushing in adjusting magnet (arrow) for wear.

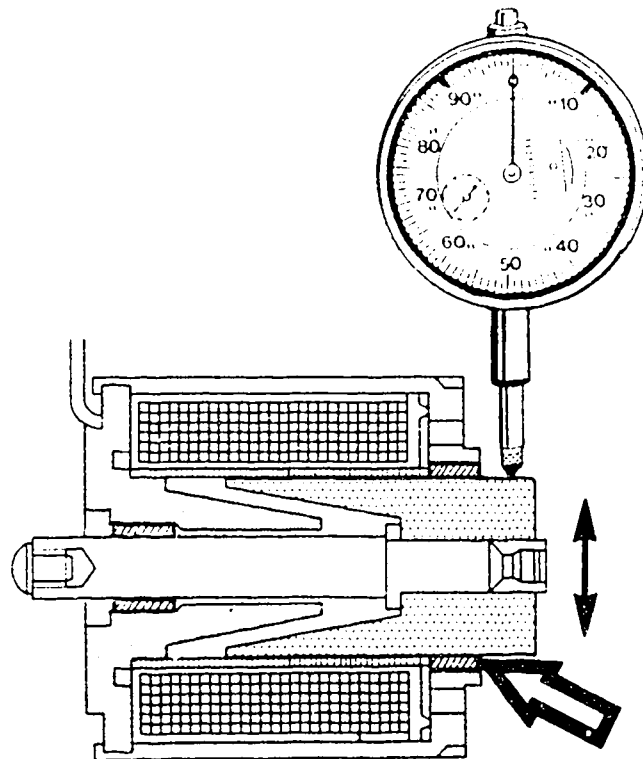
KMK 03078

The max. bearing clearance for the large bushing is 0.12 mm.

Procedure: Place magnet in prism.
Pull electromagnet armature somewhat
out of housing and align dial
indicator at armature directly
adjacent to large bushing. Move
armature in vertical direction within
bearing clearance; in doing so, turn
magnet in prism to several positions
and establish maximum bearing
clearance.

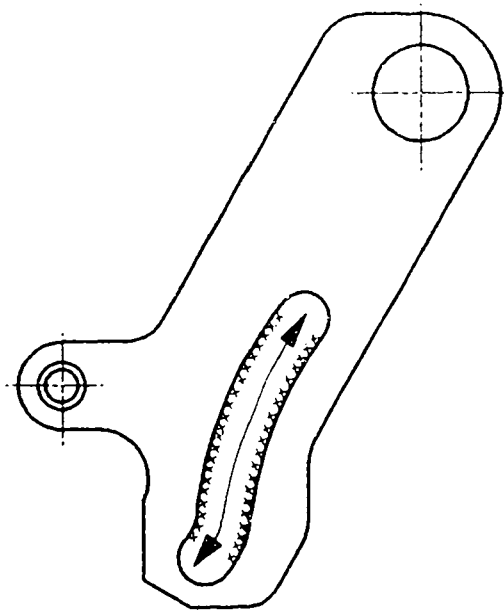
KMK01710

The cam need not be renewed if there are shiny areas in the working area of the driving pin, but no noticeable scoring.

The cam is to be renewed if one of the two situations outlined above is encountered.

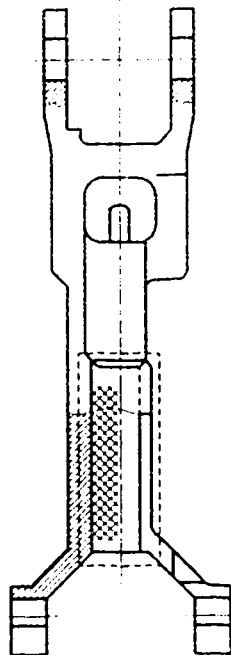
KMK01711

1. Heavy scoring or material abrasion in working area of variable-fulcrum lever guide
2. Pocket-like wear in working area of variable-fulcrum-lever guide

The variable-fulcrum lever need not be renewed if there is slight tracking, but no noticeable scoring, in the working area of the variable-fulcrum-lever guide.

The variable-fulcrum lever is to be renewed if one of the two situations outlined above is encountered.

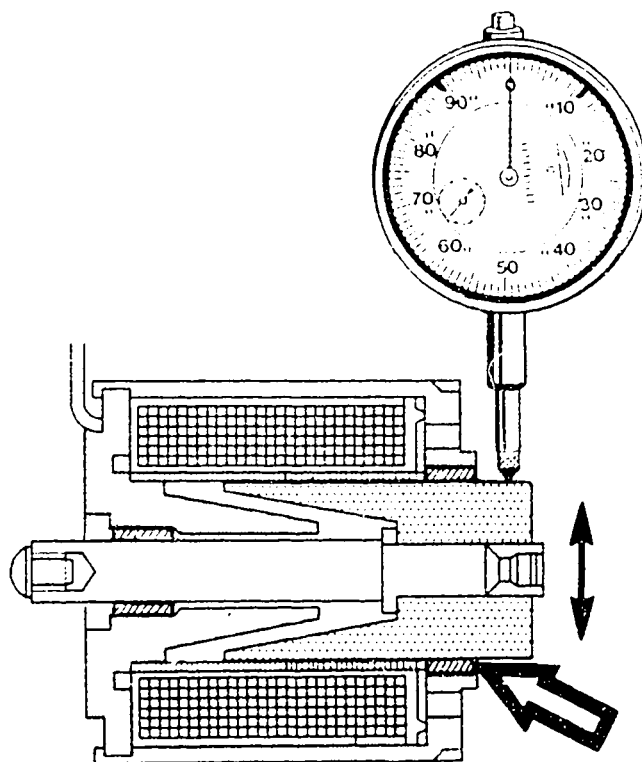
KMK 03078

This complaint may be due to a stiff armature in the RE-positioner solenoid resulting from (usually one-sided) wear of the large armature bushing (picture, arrow).

Normal testing of the IP assembly on an IP test bench does not reveal such wear. When confronted with the above complaint, the solenoid is therefore to be removed and the bearing wear measured.

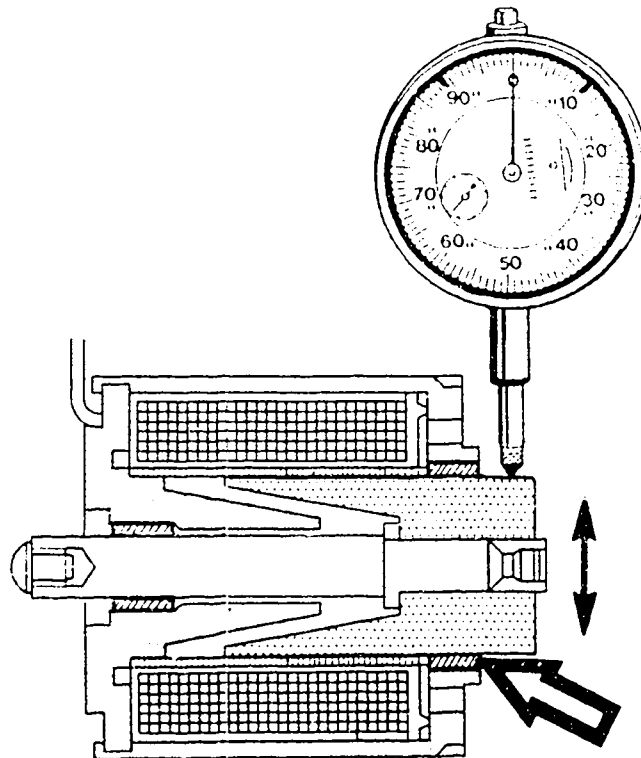
KMK 03078

- Completely remove positioner cover.
- Unsolder electrical connections of control-rod-travel sensor and adjusting magnet at connection plate (pay attention to soldering specifications).
- Remove control-rod-travel sensor and adjusting magnet.
- Check large bushing in adjusting magnet (arrow) for wear.

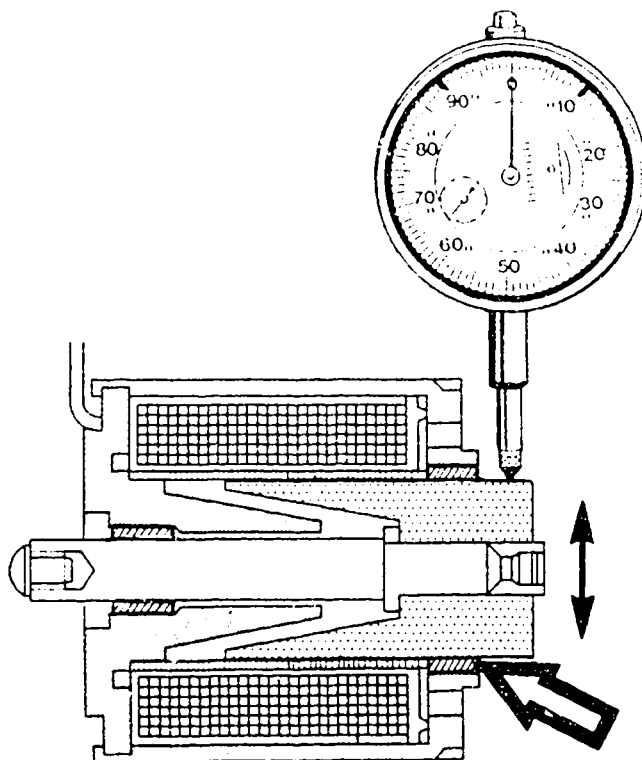
KMK 03078

The clearance for the large bushing must not exceed 0.15 mm.

Procedure: Place magnet in prism.
Pull electromagnet armature somewhat
out of housing and align dial
indicator at armature directly
adjacent to large bushing. Move
armature in vertical direction within
bearing clearance; in doing so, turn
magnet in prism to several positions
and establish maximum bearing
clearance.

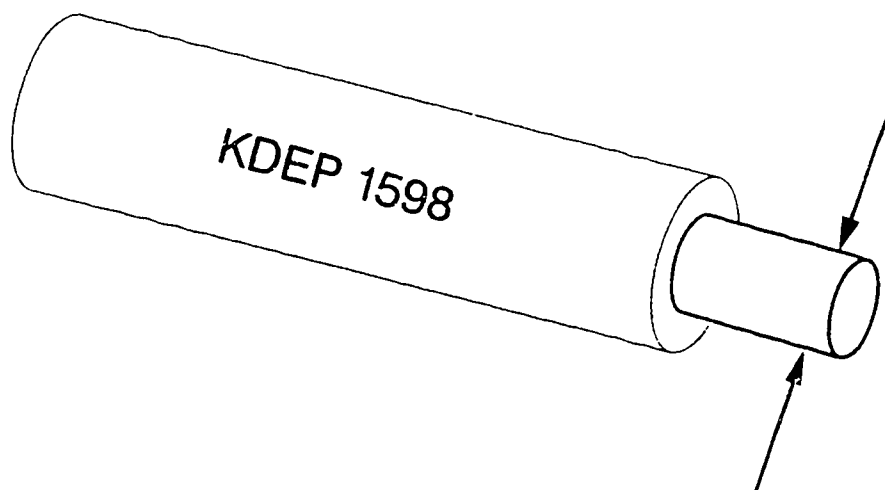
KMK04724

An increase in the wall thickness of cup plug 1 410 505 012, used for sealing the roller tappet lifting tool access bore, has necessitated a reduction in the diameter of insertion tool KDEP 1598. See illustration.

Reduce the diameter of the pilot pin by 0.4 to 0.5 mm to a diameter of 10.0 - 0.1 mm.

This will enable the tool to be more easily withdrawn from an inserted cup plug and will prevent the possible cracking of the pump housing during the cup plug insertion process. The modification of this tool will not affect its use on cup plugs made prior to the change.

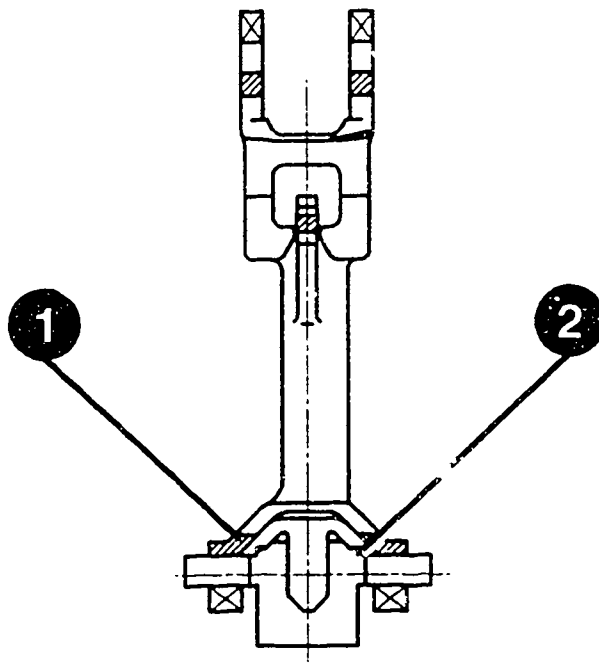
KMK02601

When checking whether contact is made, it must be ensured that the parts are centered as illustrated.

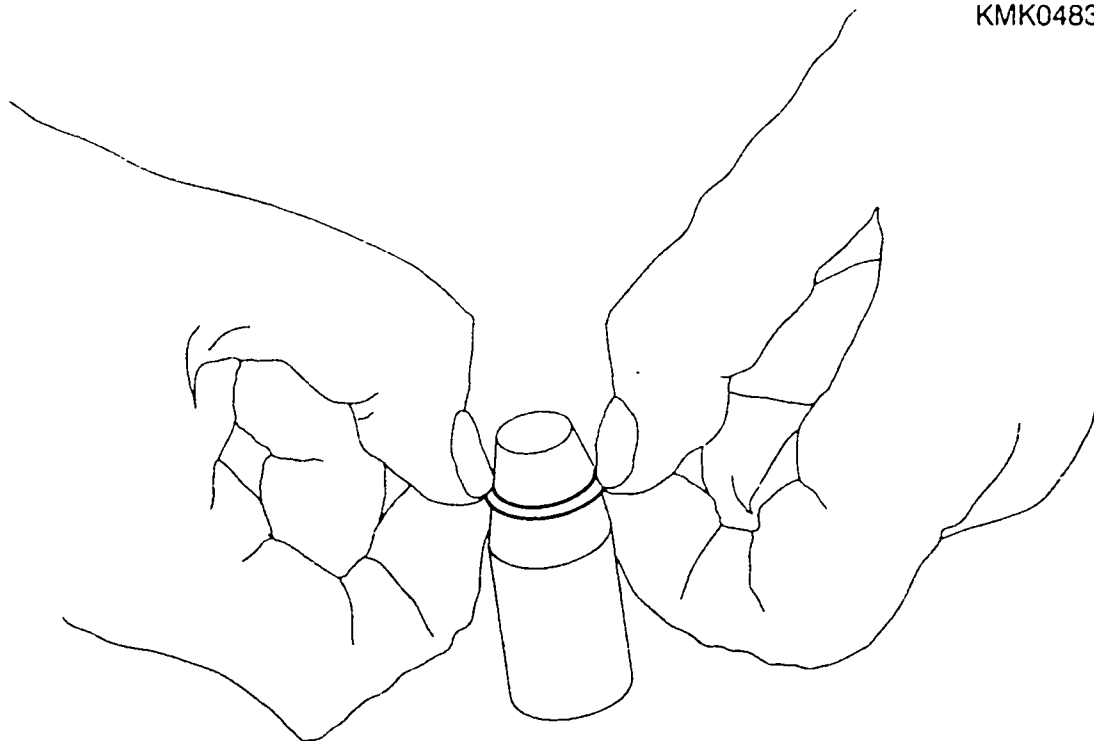
KMK04839

If this happens, permanent deformation will result and the ring must be scrapped.

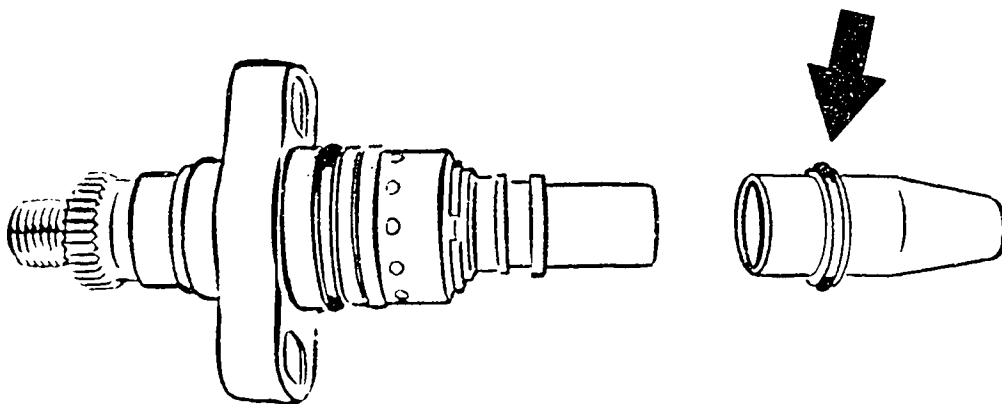
KMK 03652

Slide inner part with support ring/O-ring/support ring (arrow) over assembly as far as they will go.

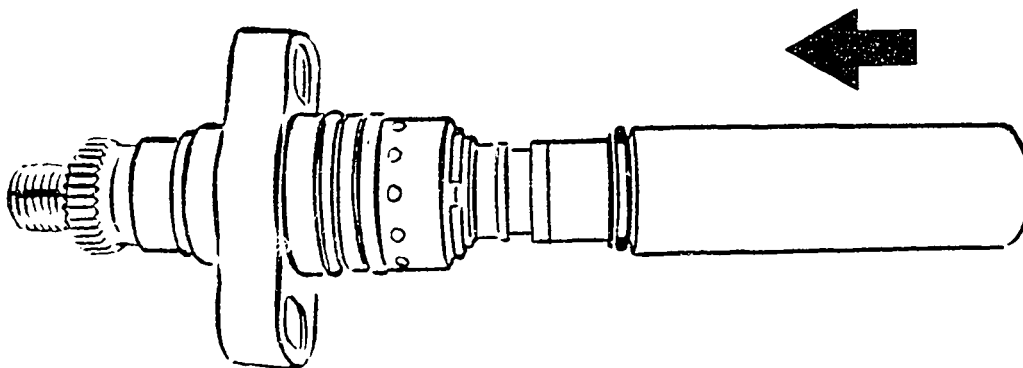
KMK 03653

Slip support ring/O-ring/support ring
with outer part of assembly device
0 986 612 495 onto assembly (picture).

In doing so, make sure support ring
does not collapse.

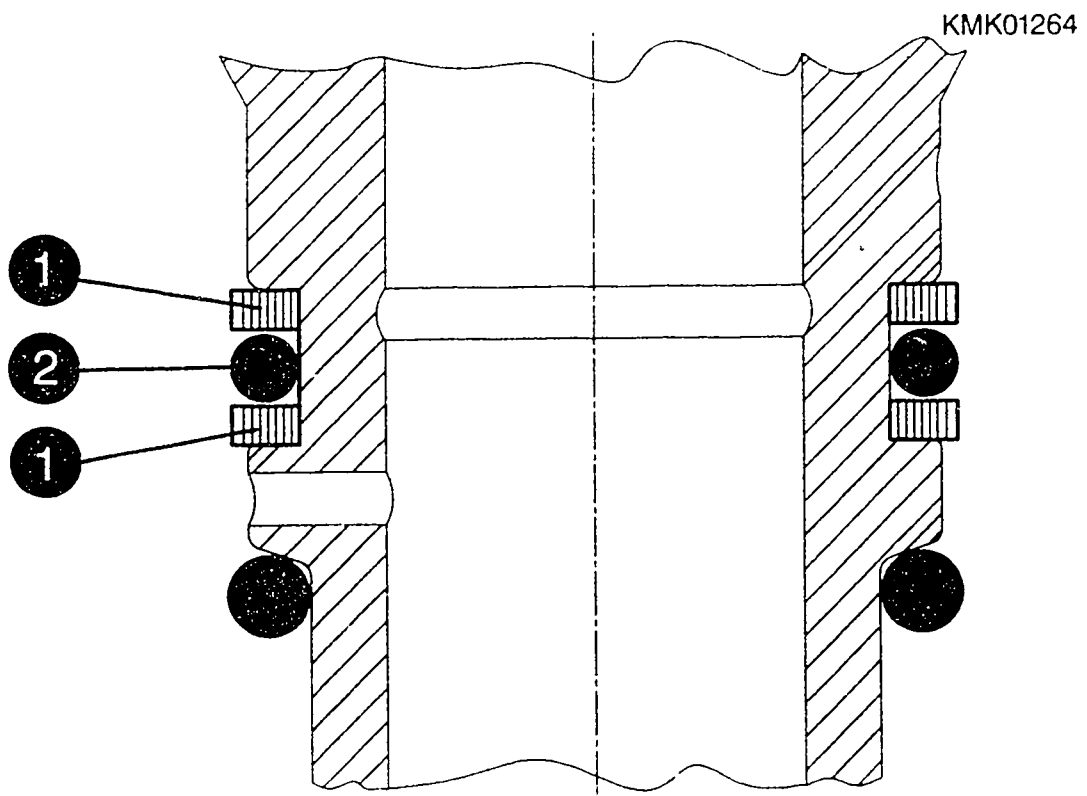
Check whether support ring (1)/
O-ring (2)/support ring (1) are
correctly positioned as shown.

- * When performing repairs, support rings and O-rings already fitted are to be replaced with new ones.
- * Support rings which collapsed on assembly are to be replaced with new ones.
- * Pump housings and plunger-and-barrel assemblies of old (slotted support ring) and new (solid support ring) versions are identical. Slotted support ring can therefore simply be replaced by solid type.

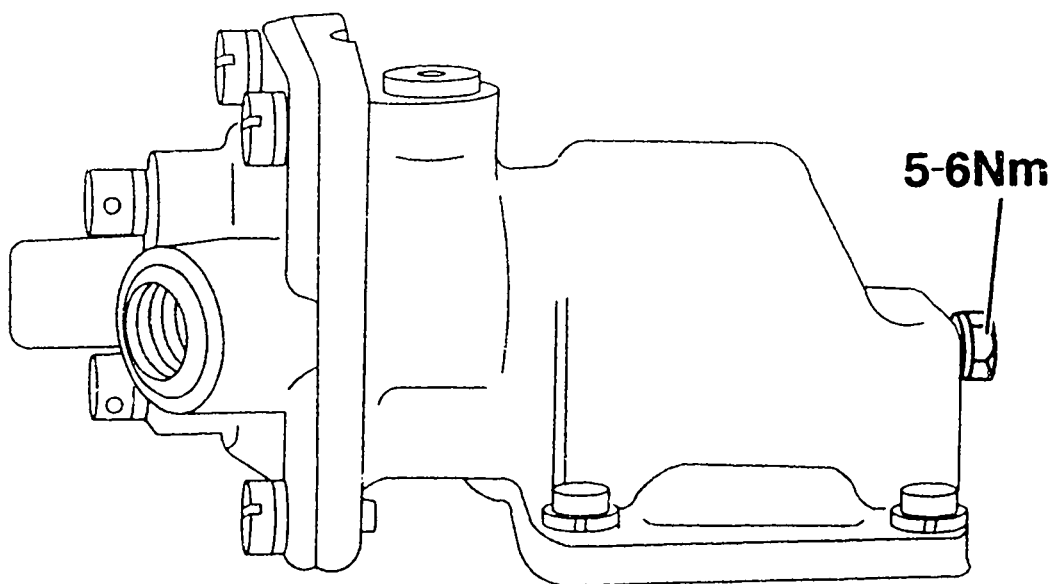
KMK04725

When performing starting fuel quantity adjustments on P-7100 injection pump combinations using top-mounted LDA assemblies, be certain to apply the correct torque to the locking screw and ensure that there is full movement capacity of the stop part after doing so. The specified torque of the locking screw is 5...6 Nm (see illustration).
